# LIFE RESKIBOOT

## MID-TERM SECTORIAL TECHNICAL WORKSHOP

Design for recycling

UNIBO

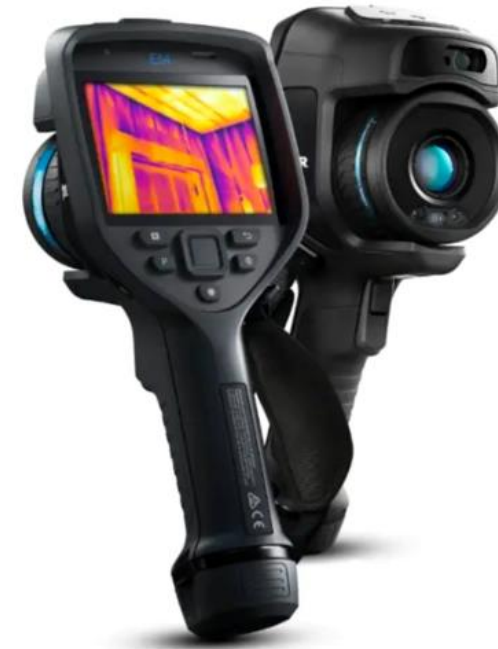
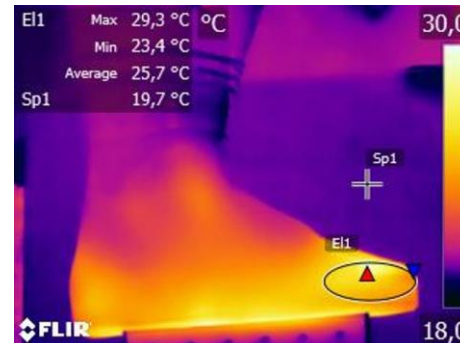
## Thermal Insulation Analysis of the Liner

0 seconds

300 seconds

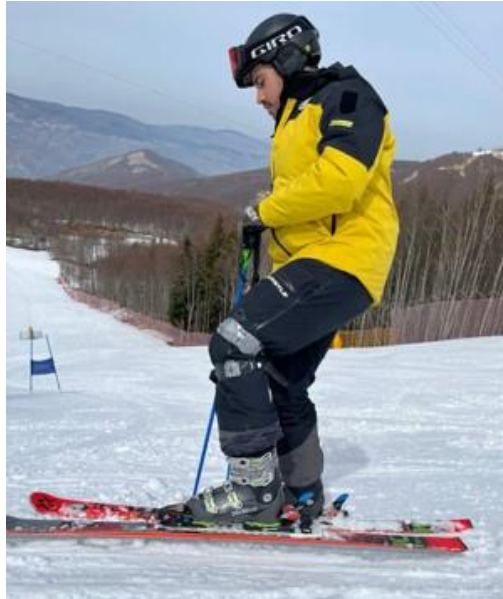
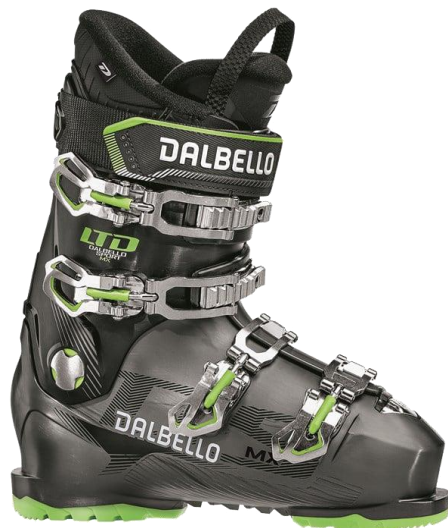
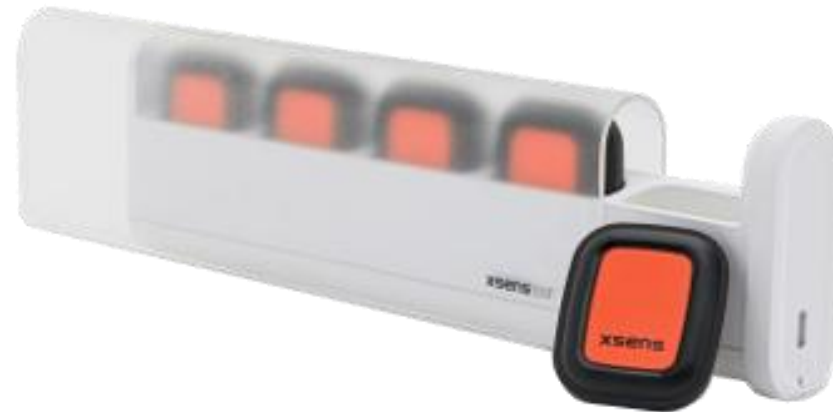
On field tests of the skiboot

We defined a protocol to follow for on field tests using the Xsense IMU system and pressure sensor to evaluate the kinematics of the ski and to be then included in the tests at the walkmeter.

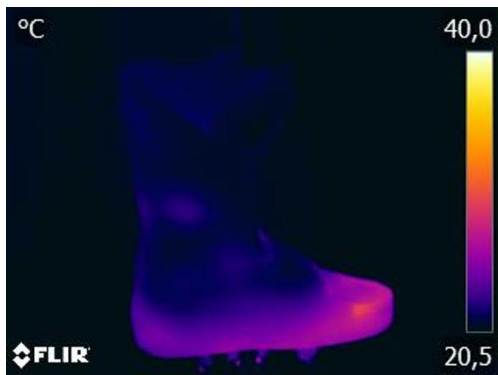
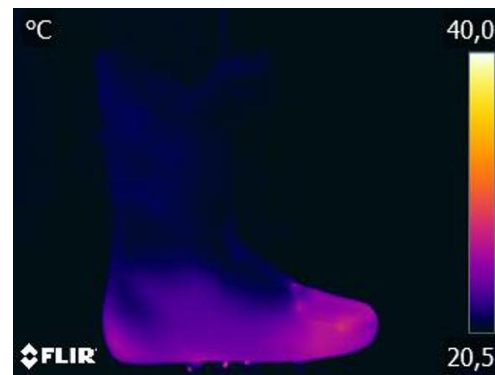
New

20 days of use

50 days of use

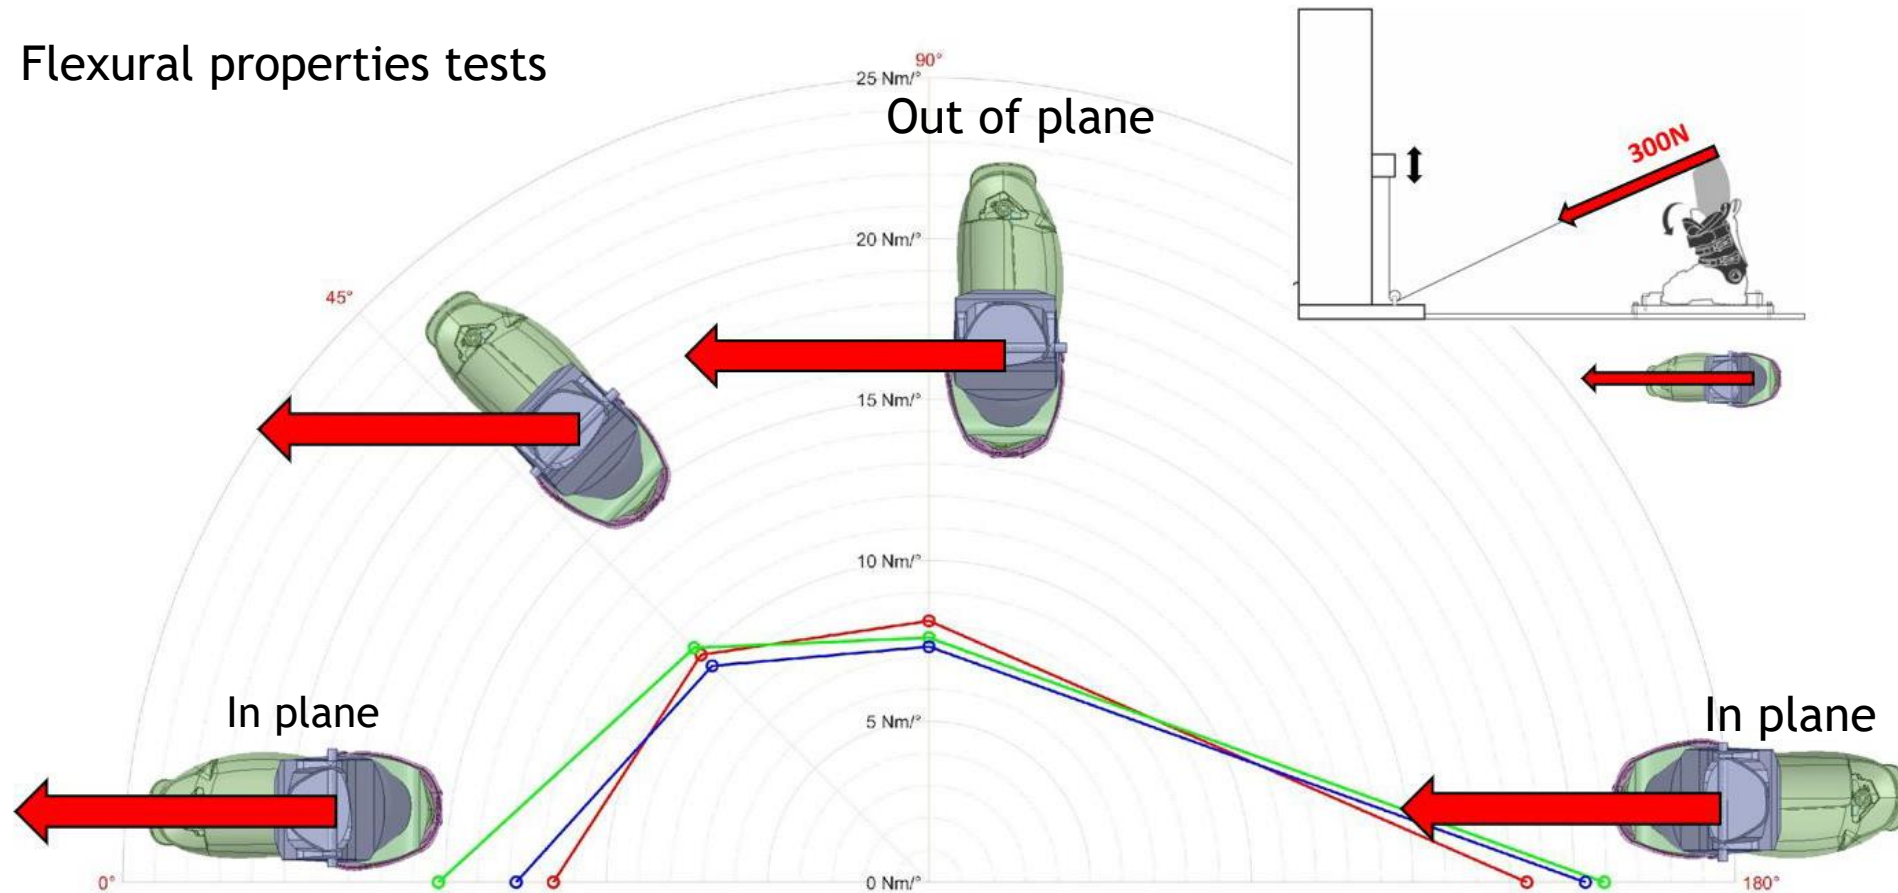
## Flexural properties tests

We conceived and realized a novel method to fully characterize the stiffness response of the skiboot «in plane» and «out of plane».

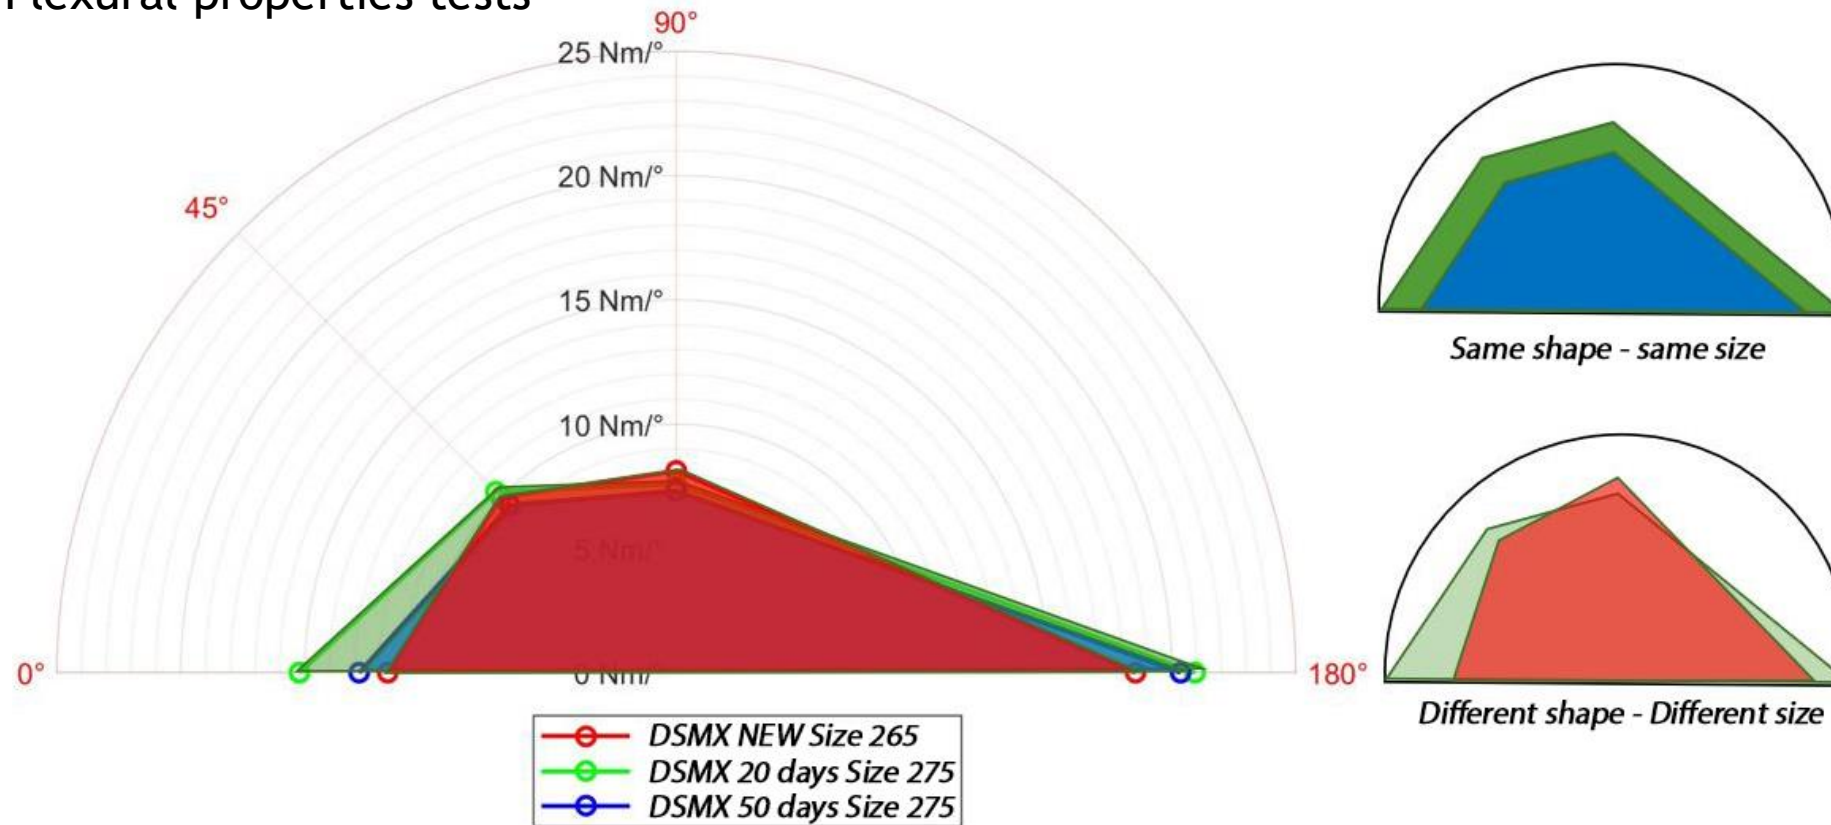
## Flexural properties tests

The days of use of the boots have a not negligible effect (-20%) on the flex properties of the boot.

Therefore the 20% reduction on the flex property of the skiboot is not given by a degradation of the material but by other factors such as the loss of closure of the rivets and the hook system.

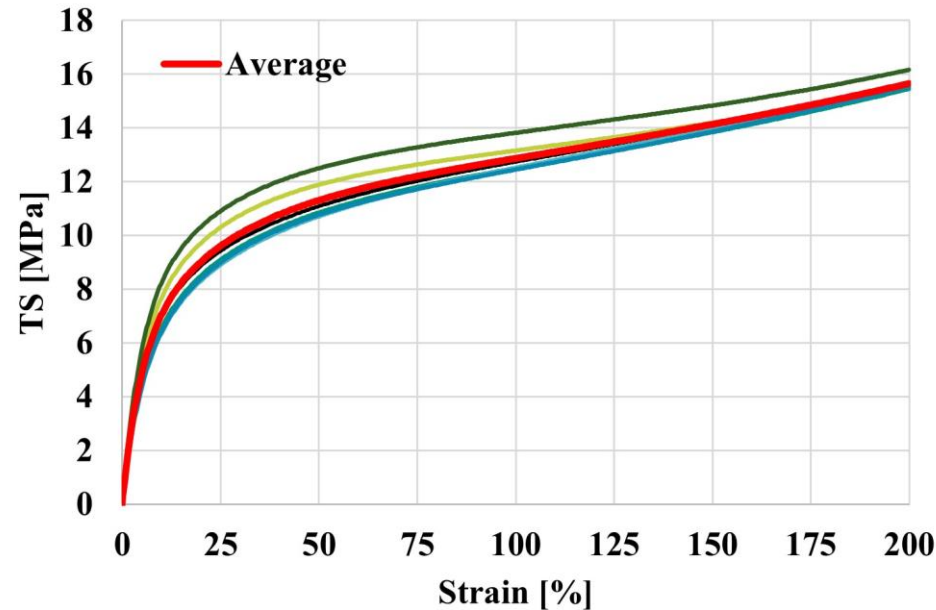
## Aged material mechanical characterization

E [MPa]	TS [MPa]	el,break [%]
Shell 0 days	182 ± 18	44 ± 4	791 ± 72
Scafo 20 days	169 ± 8	47 ± 1	816 ± 17
Scafo 50 days	169 ± 12	44 ± 1	821 ± 36

We investigated whether the reason for the flex reduction. With the tensile test on the materials we can claim that, there are no differences on the Young Modulus, Tensile Strength and Elongation at break connected with the use of the skiboot.

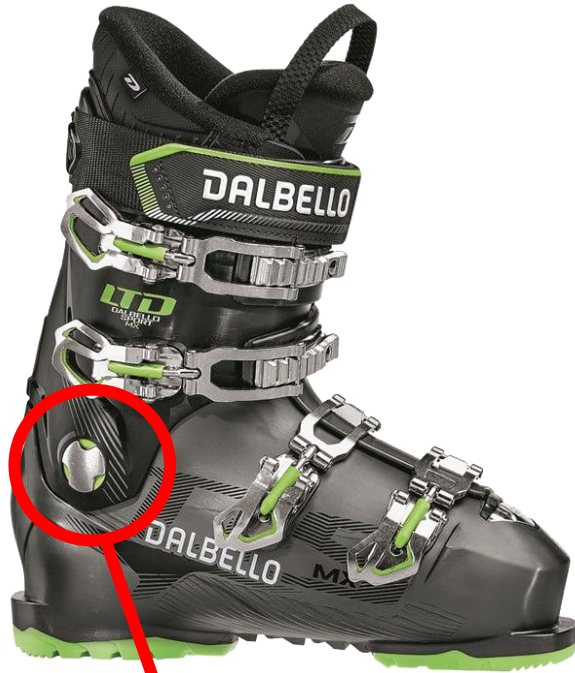
## Rivets replacement

For this reason it was decided to replace the rivets with screws in order to be replaced in case of performance loss.

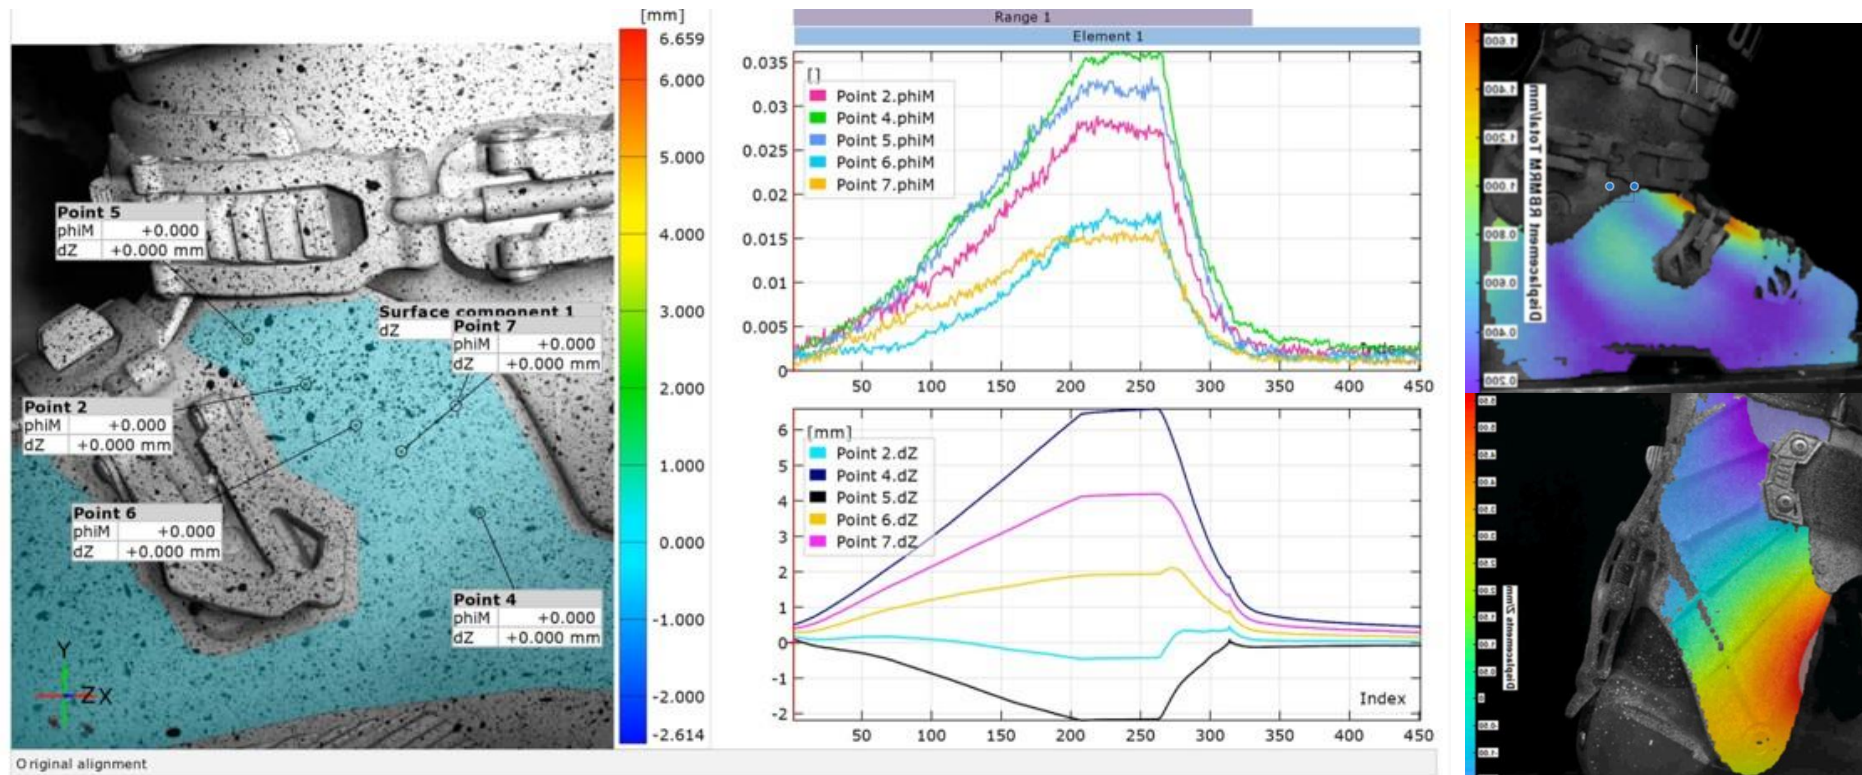
## DIC analysis and FEM Model validation

Thanks to the use of the DIC (Digital image correlation) it was possible to validate the results of the FEM analysis and have a starting point for the redesign with topological optimization of the boot.

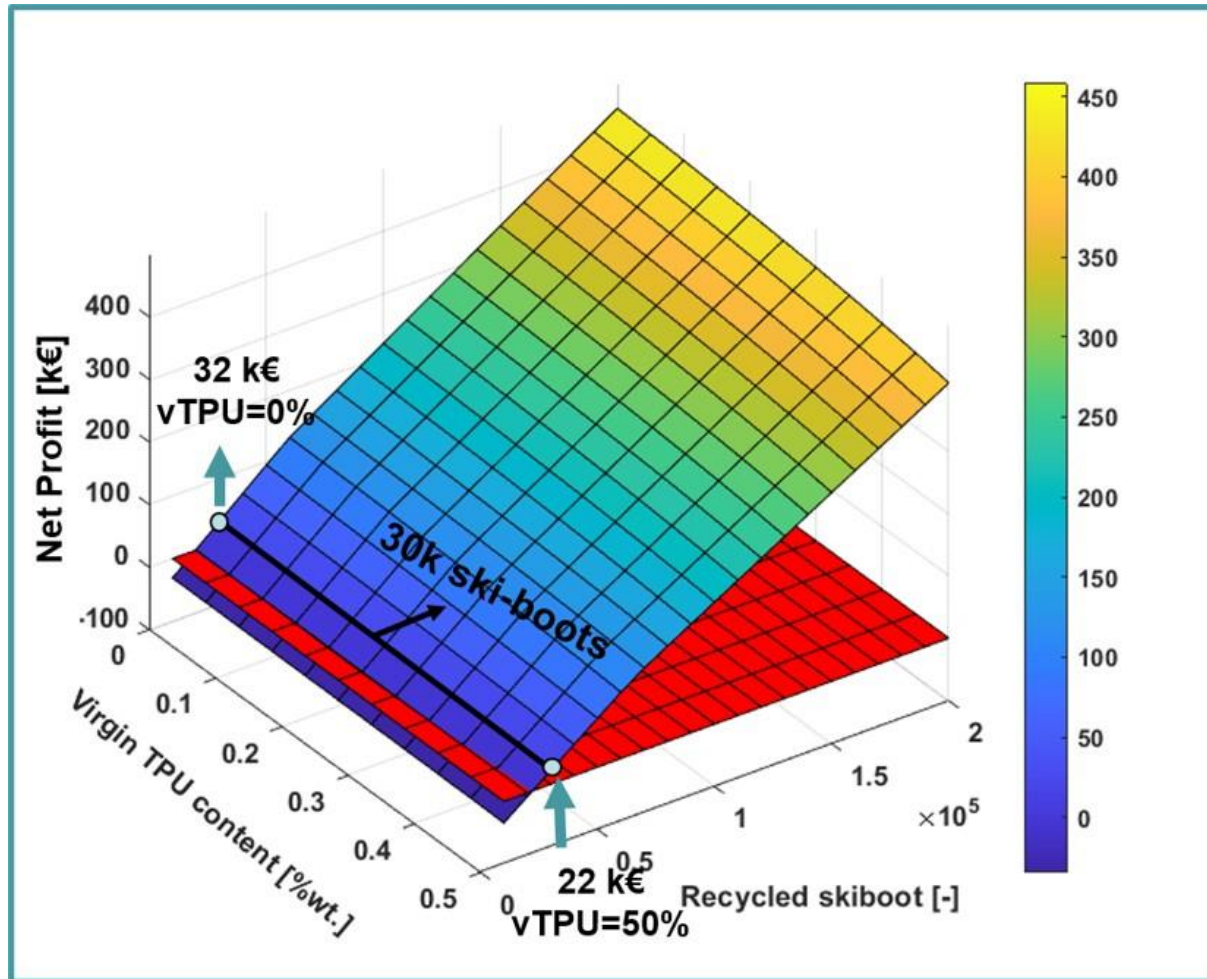
Techno economic analysis of the process

To perform the recycling processes with third-part existing companies at least 30000 ski-boots are needed (60000-70000 are desirable for good values of profit) while, to build up a dedicated recycling plant from zero, at least 100000-110000 ski-boots have to be available (140000-180000 are desirable for good and fast returns).

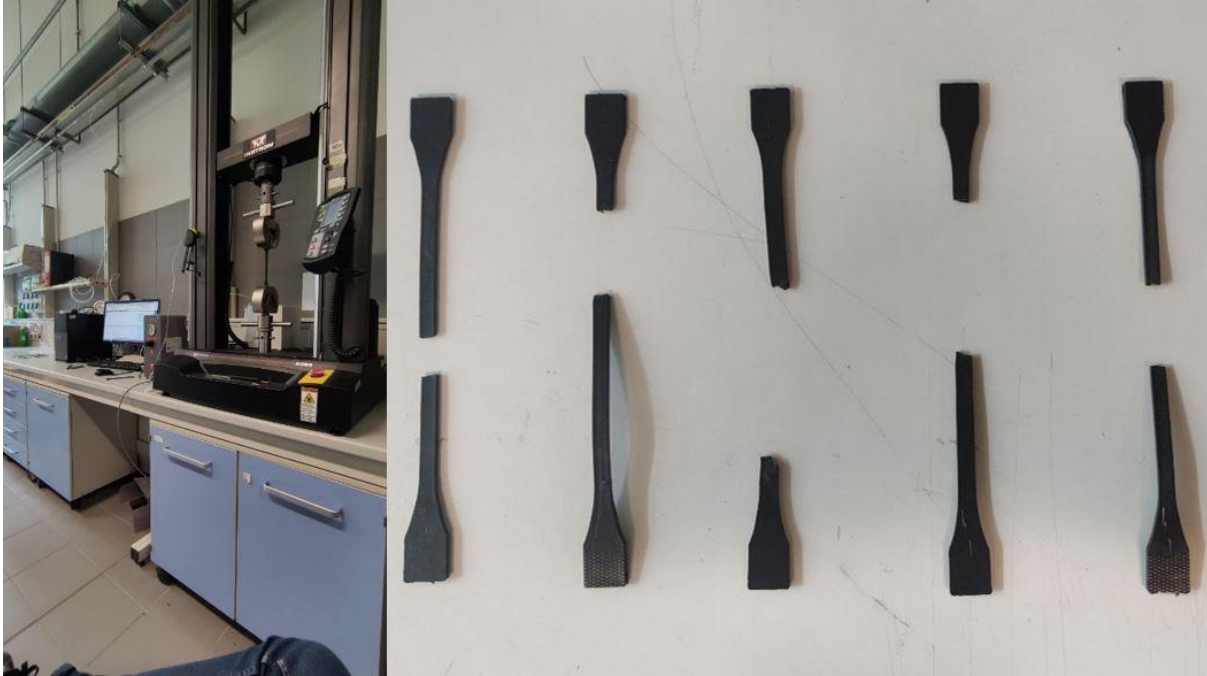
## Recycled material characterization

From laboratory tests on TPU samples it is clear that the material remains perfectly suitable for the manufacturing of new ski boots.

Sample	R-TPU 1	R-TPU 2	R-TPU 3	R-TPU 4	R-TPU 5	Average	Gap
Modulus (MPa)	311.13	320.22	322.76	342.04	314.43	322.17	+109%
T.S. Max (MPa)	18.41	16.99	15.77	18.42	18.7	17.65	-62%
Elongation at break (mm/mm)	2.46	2.02	1.29	2.24	2.36	2.07	-78%
